Phase I Environmental Site Assessment  
Supplemental Report  
St. George Airport

March 2003

Phase I Environmental Site Assessment  
St. George Airport  
St. George, Utah

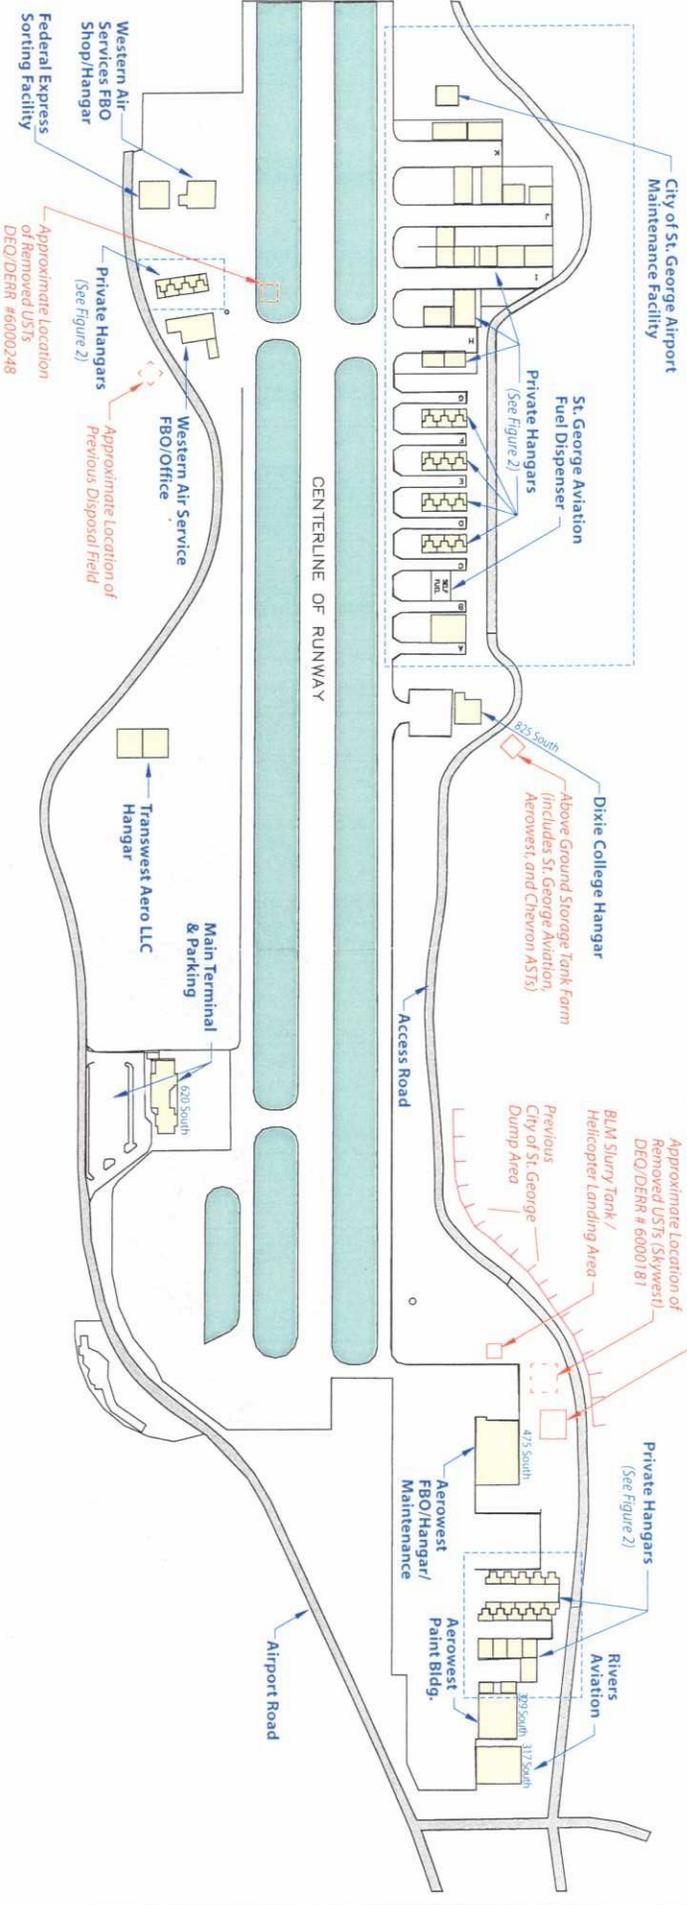
**Figure 1 - Airport Site Plan**

A Site Plan is shown as Figure 1. The Private Hangar facilities shown on Figure 2 are keyed to a tenant list included as Appendix A. The map and list of tenants was provided by Mr. Ulane and is current as of February 2003. Photographs of the Site are included in Appendix B.

underground storage tank (UST) facility identification number #6000248 for Western Air Service is shown on Figure 1.

The existing Aerowest FBO is a sub lessee of Skywest. In some of the documentation the property has been referred to as Skywest Aviation. The DERR UST identification number for the Aerowest property is #6000181, and is shown on Figure 1.

Two USTs (#6000181) were removed from the Aerowest property in 1998. The approximate location is shown on Figure 1 and the DEQ/DERR close out letter for the tanks is included in Appendix C. Mr. Houston noted the location of the removed USTs, to the southwest of the Aerowest building.

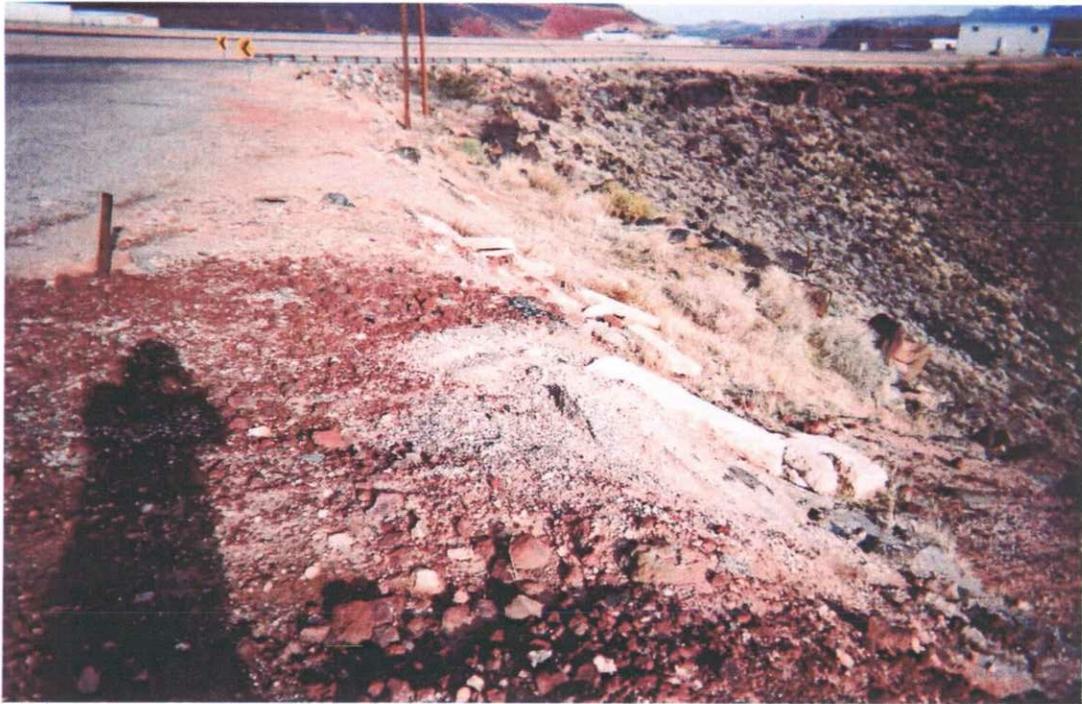
The area to the east of the existing Western Air Service building and airport road, was observed for evidence of a previous leach field or disposal field. This area was identified in a 1969 airport layout plan as the approximate location of a previous disposal field. Concrete pieces, rebar and a pipe extension were observed. The area is at the edge of the ridge and the material is very rocky (see Appendix B – Photographs). Mr. Johnson reported that the pipe extension was the base of an old sign that had been removed. He also reported that there was not a disposal field located at the airport, to the best of his knowledge and recollection.

Approximate location of previous leach field “disposal field” to the east of the Western Air Services building (looking north)

As there were no aircraft maintenance activities conducted at this location, and the leach field was only utilized for the purposes of the restroom facility (natural waste), the potential for contamination at this location is very minimal. PB does not recommend further investigation at this location.

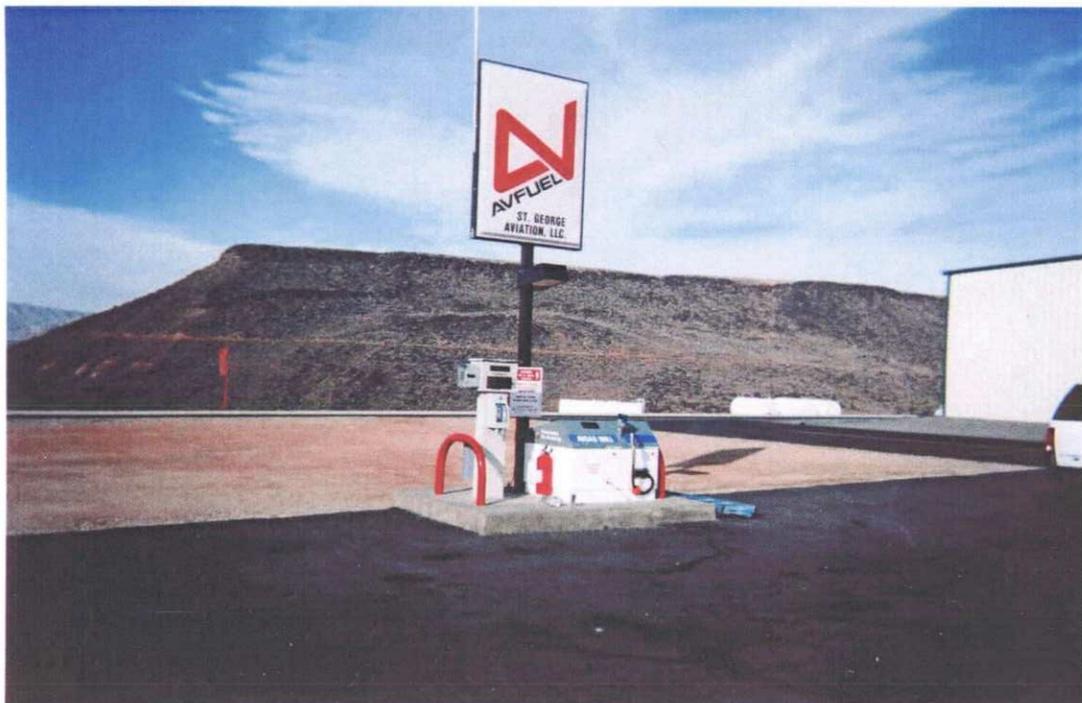
St. George Aviation dispenses 100 LL AvGas fuel at a location near the runway. The fuel is stored in the most southern AST within the tank farm area. The tank is double-walled and is not located within a containment area. No spills were observed at this location. The tank and self-service dispenser were installed in 2002.

St. George Aviation fuel dispenser (looking west)

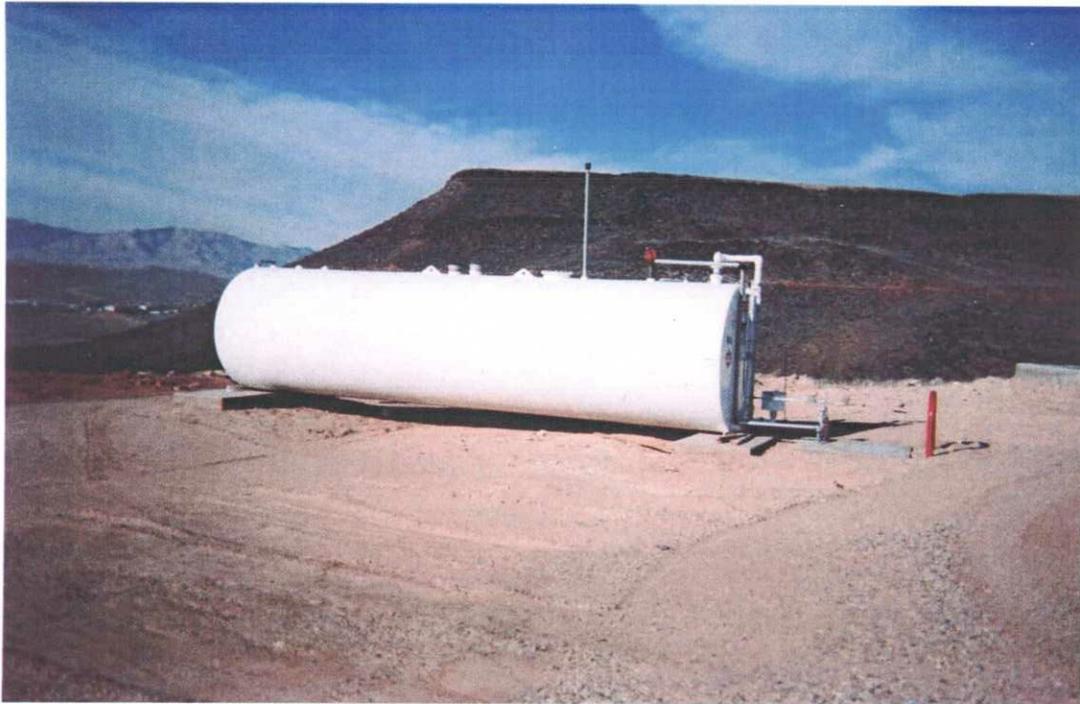
St. George Aviation aboveground storage tank – steel, double-walled (looking northwest)

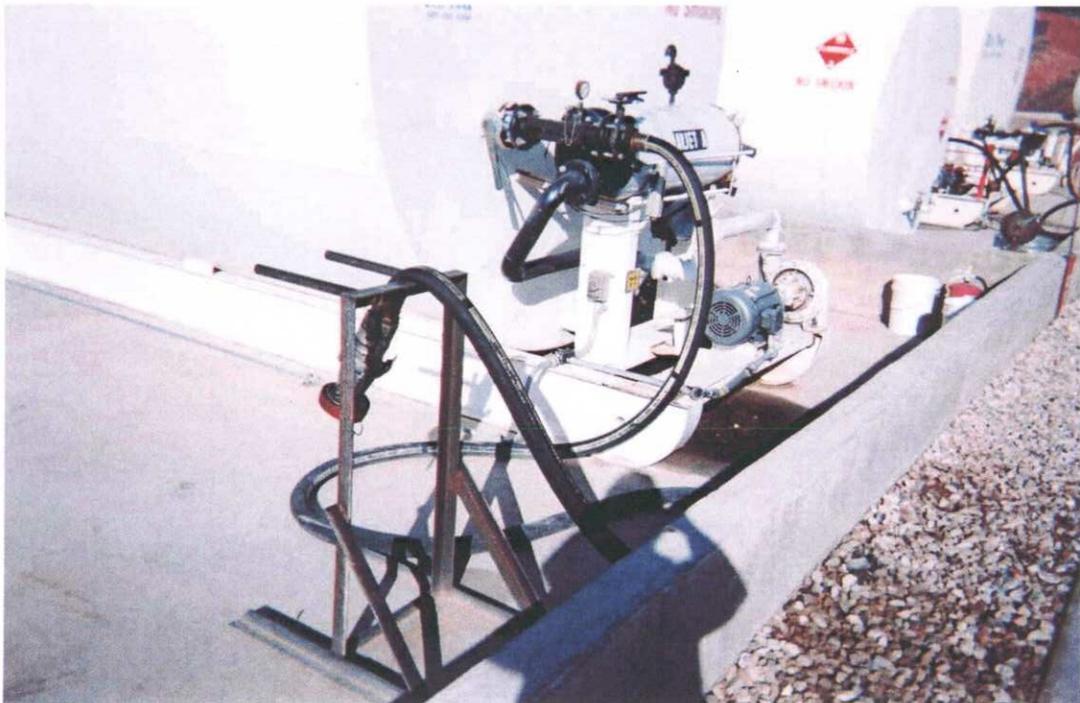
The Aerowest AST area is located immediately north of the single St. George Aviation tank. Three 12,000 gallon tanks (100 LL AvGas and Jet A) and one 3,000 gallon empty tank are contained within the concrete containment area. Cracks were observed in the containment area, as well as open buckets of unknown product, possibly sump test water. A drain is located within the containment area which is connected to PVC piping that has been constructed to drain to the west of the area, near the west side of the ridge. The piping and shut-off valves are broken. Fuel

spills were observed in the containment area, and in the soils and gravel around the containment area (see Appendix B – Photographs). To the west of the containment area is a full, open container (1/2 55-gallon barrel) containing sump test water. Soil stains were observed near the barrel.

Cracks were observed in the concrete of the Aerowest containment area. Petroleum hydrocarbon stained soils were observed at the east and west ends of the containment area. The sump test water barrel was open and full, and there appeared to be spills around the barrel.

Aerowest Tank Farm (looking northwest) – leaks/spills within and outside of containment area

- Re-establish the integrity of the containment area by sealing the cracks
- Repair overflow pipes and valves or close drains
- Establish protocol for sump water testing and maintenance of tanks and containment area
- Provide closed 55 gallon barrel for sump water test disposal

PB recommends that soil be sampled at the east and west ends of the Aerowest containment area. Collect and analyze soil samples for petroleum hydrocarbon constituents at ground surface and at various depths, 2 feet and 4 feet if possible (using a hand auger) at both ends of the containment area and near the sump test barrel.

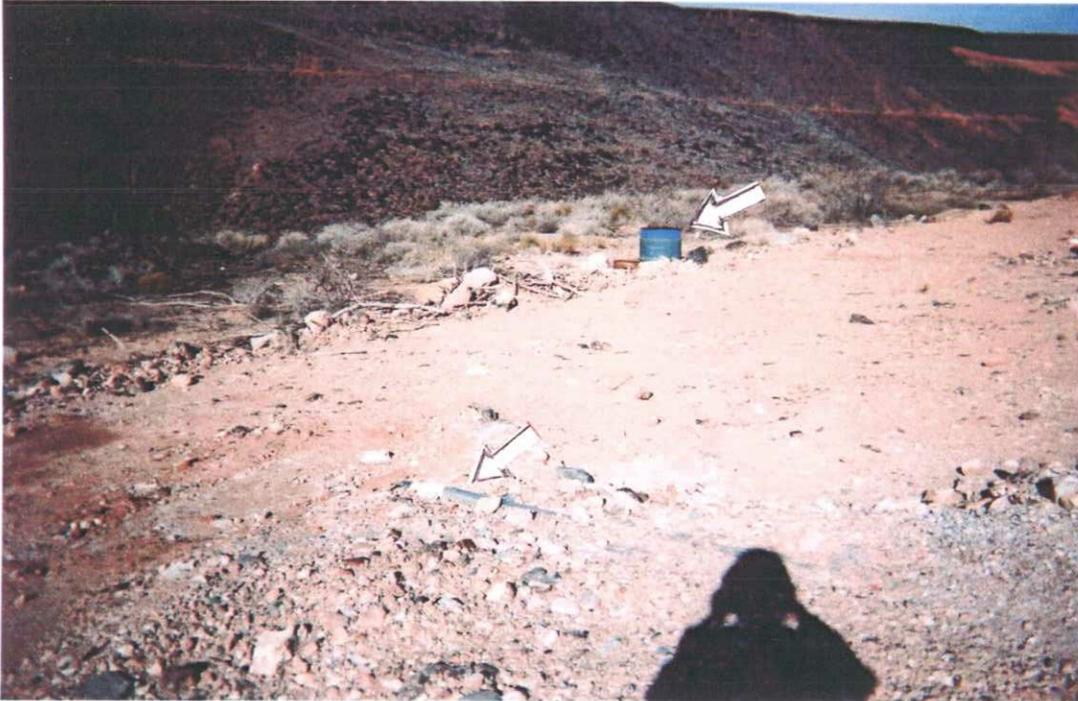
Drains are located within the Aerowest and Chevron containment areas. The overflow pipes and valves connected to the drain are broken. This may allow spilled fuel to drain out of the containment area onto the ground surface.

Damaged valve and overflow pipe from containment area (looking northwest)  
Sump test water barrel located west of containment area

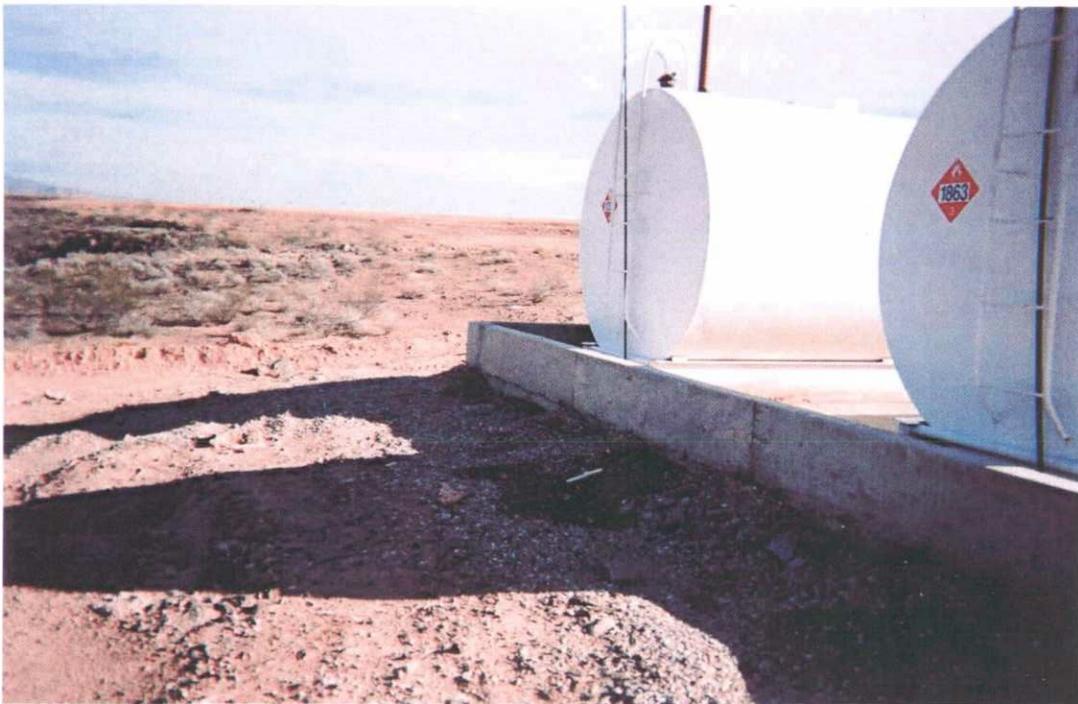
The Chevron AST area is located north of the Aerowest ASTs. Two 12,000 gallon tanks, 100 LL AvGas and Jet A, are contained within a concrete containment area. Standing water was observed, however there was no sheen or odor on the water. A drain is located within the containment area which is connected to PVC piping that has been constructed to drain to the west of the area, near the west side of the ridge. The ends of the pipe are broken. Soil staining was observed just outside of the containment area (west side) near the Jet fuel tank and at the shut-off valve.

Chevron Tank Farm (looking north) – soil staining outside of containment area and next to shut-off valve

PB recommends that soil samples be collected and analyzed for hydrocarbon constituents at the west side of the Chevron containment area and at the shut-off valve.

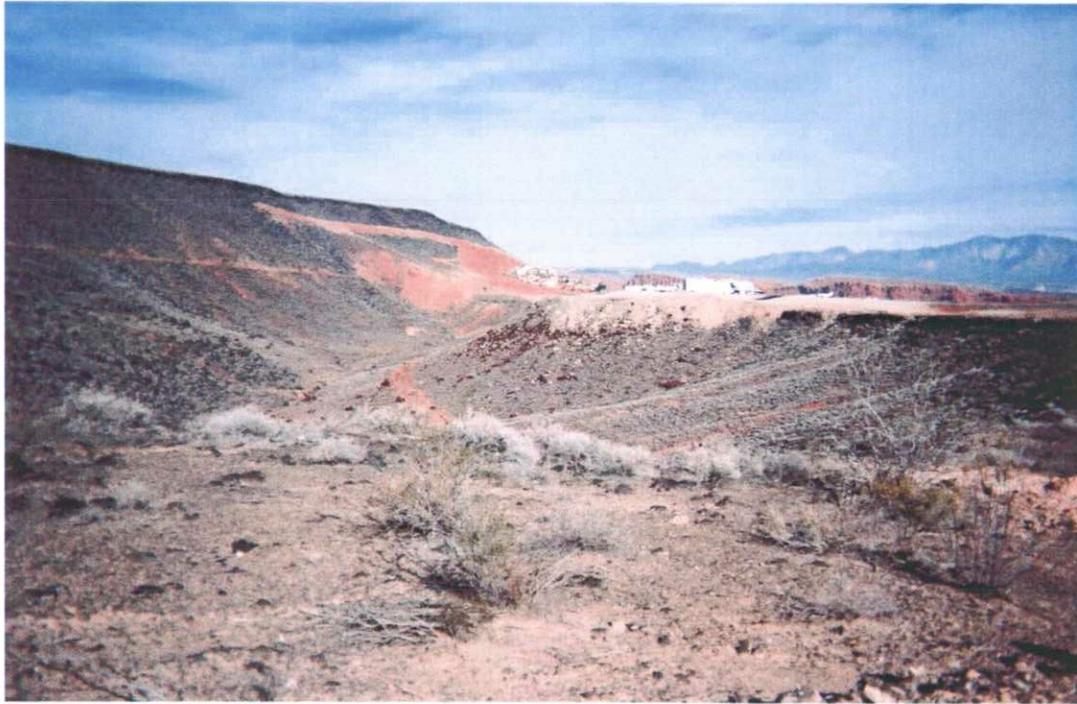
The dump area is located along the western ridge of the airport property. Dumping has occurred at the edge and over the edge into the ravine below. According to Mr. Ulane and Mr. Johnson, the dump is fenced off to the public at the northwest edge and bottom of the ridge, and has not been used for approximately 40 years.

Looking north at previous dump area and Aerowest building (from tank farm location)

According to Mr. Ulane, materials from the previous dump area will be removed in the near future. Construction materials can be disposed of in the existing landfill. PB recommends that the barrels and containers be examined for product and labels, and disposed of properly. PB recommends that barrels or containers containing product, without labels, be sampled and analyzed according to the recommendations of the nearest landfill that accepts hazardous materials.

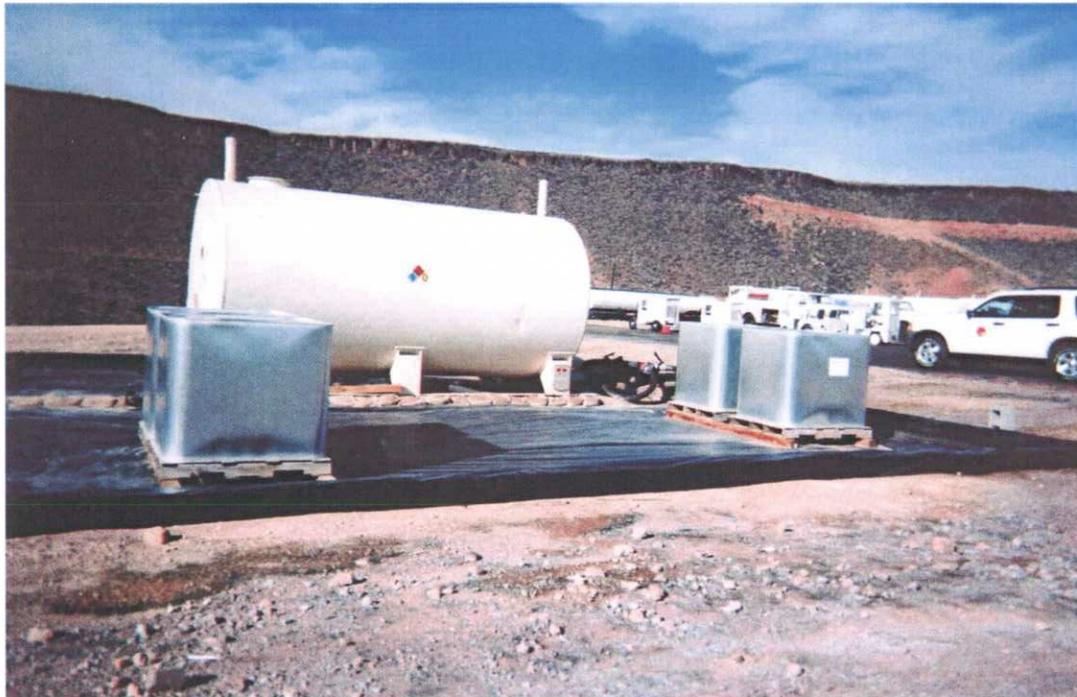
The BLM maintains a helicopter landing and loading area for fire-fighting purposes. The BLM area is located to the south of the Aerowest building. The 6,000 gallon water storage tank and materials are located on polyvinyl sheeting. The materials stored in the area are Diammonium Sulfate and Diammonium Phosphate granules, which are mixed with water for the slurry. According to Mr. Ulane, there are plans to build a containment area in the Spring of 2003 for the tank and materials. No spills or leaks were observed in this area.

BLM slurry storage tank (looking west)

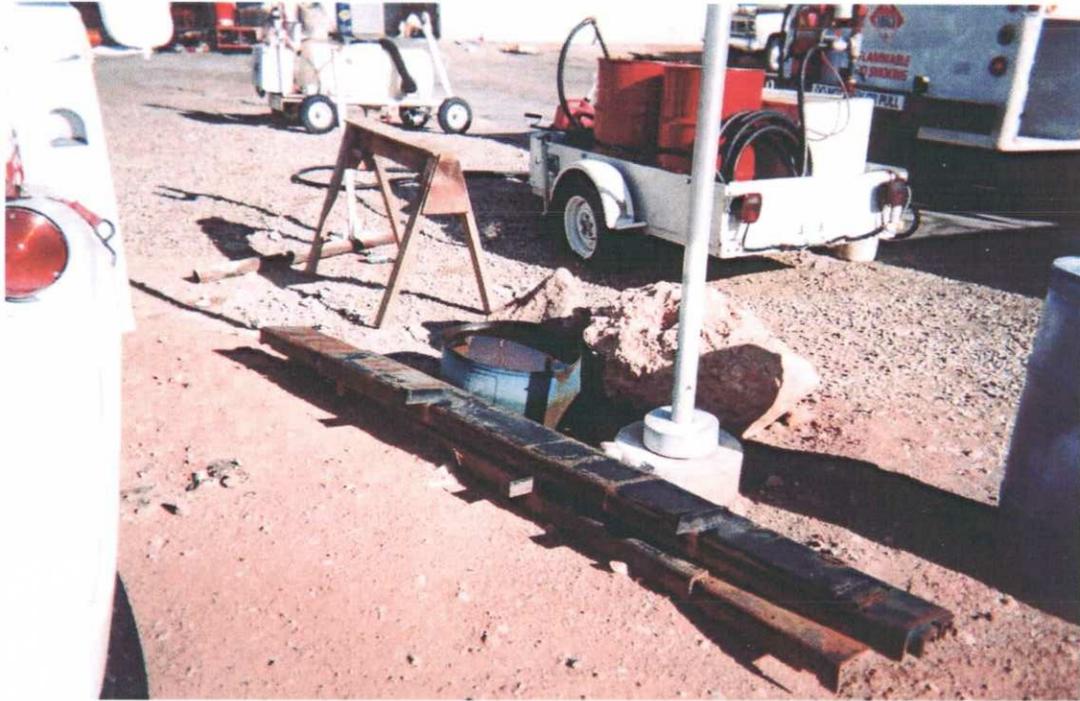
An open barrel containing sump test water, similar to that seen at the AST farm, was observed southwest of the building in the equipment area. Near the sump water barrel, were several 55 gallon unlabeled barrels. Mr. Houston said that the used oil and sump fuel barrels were hauled off site to a business in St. George.

Sump test water barrel located southwest of Aerowest building (looking northeast)

- Remove the 55 gallon barrels of fuel from the hangar
- Cap the clean-out pipe in the parts cleaning room
- Move all barrels and containers from drain areas
- Provide a containment area for the storage of barrels and containers of fuel and solvents
- Conduct a surface and subsurface soil sampling program for the waste oil area, as the area is heavily stained

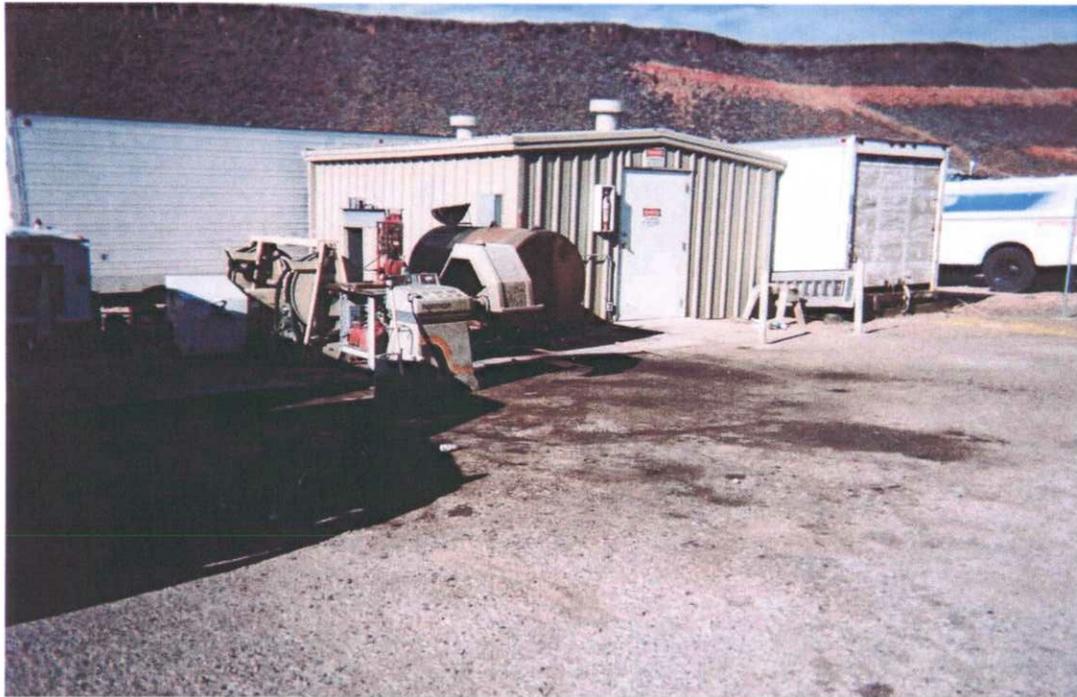
A waste oil tank on a concrete pad is located to the west of the Aerowest building. Oil has leaked into the soil and gravel to the west of the concrete pad. Oil has been spilled on the concrete pad and the area to the east of the tank (see Appendix B - Photographs). The area of oil stained soils is estimated to be approximately 1,200 square feet. Oil staining was observed several inches below surface soil staining. The depth was not determined.

Stained soils, waste oil tank and welding shop located west of Aerowest building (looking west-northwest)

PB recommends only soil sampling at the Site. Soil samples would be analyzed for petroleum hydrocarbons and solvents. It is common for solvents to be dumped into a waste oil tank.

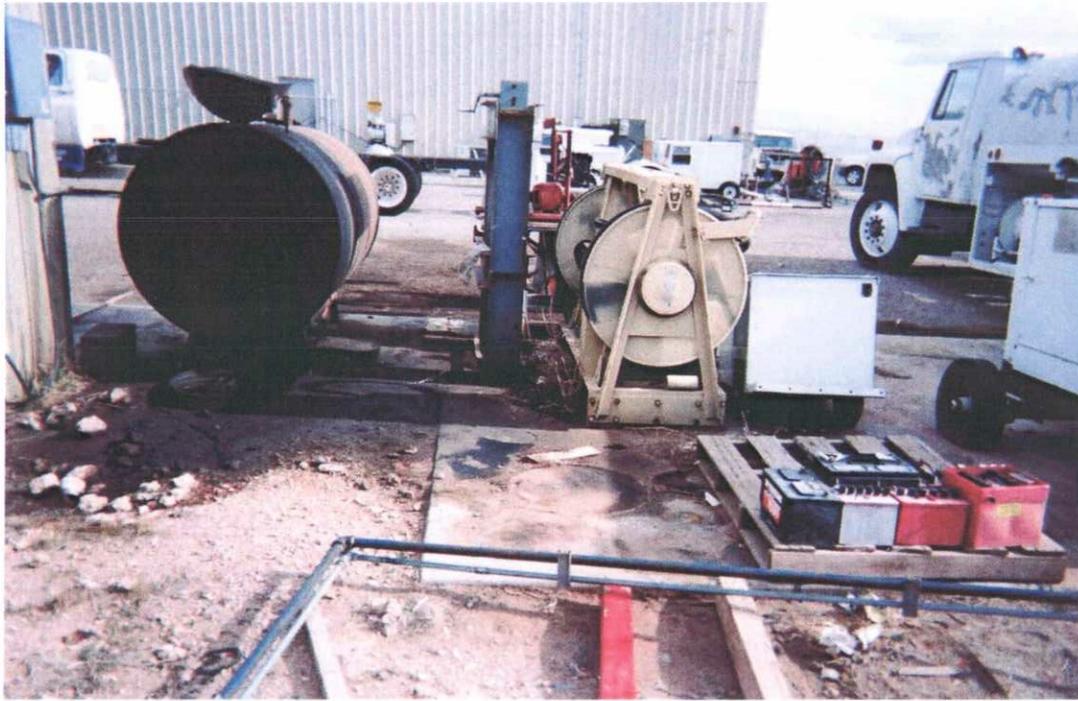
Various pieces of equipment, vehicles, trailers, tanks, and a pallet of batteries are scattered throughout the southwest and west sides of the Aerowest building. There are four old tanks of various sizes that previously held fuel. According to Mr. David Houston, the manager of the Aerowest facility the barrels are empty and are in need of repair.

Waste oil tank, miscellaneous equipment, and batteries on pallets, located west of Aerowest building (looking east)
